# **EFFECTS OF SURFACE CHEMISTRY ON HOT CORROSION LIFE**

## **FIRST ANNUAL REPORT**

**R.E. Fryxell**

**General Electric Company  
Aircraft Engine Business Group  
Cincinnati, Ohio 45215**

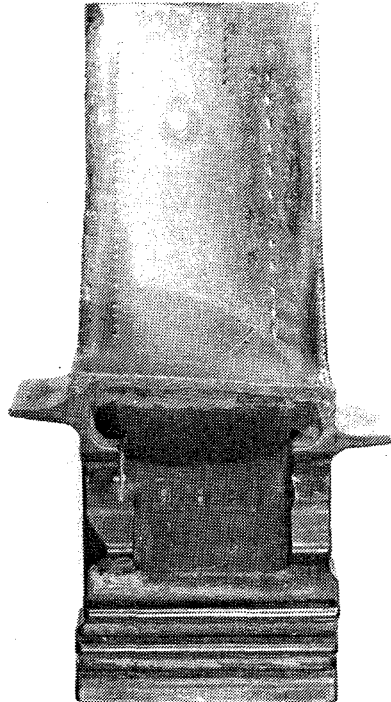
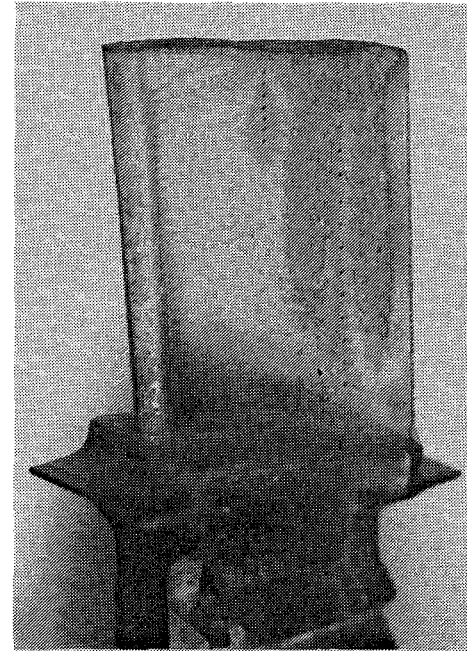
Figure 1a. Stage 1 High Pressure Turbine Blades from CF6-50 Engines.

Southern Asia: A300B  
2694 hours, 1560 Cycles

Nothern Africa: A300B  
4641 hours, 2169 Cycles

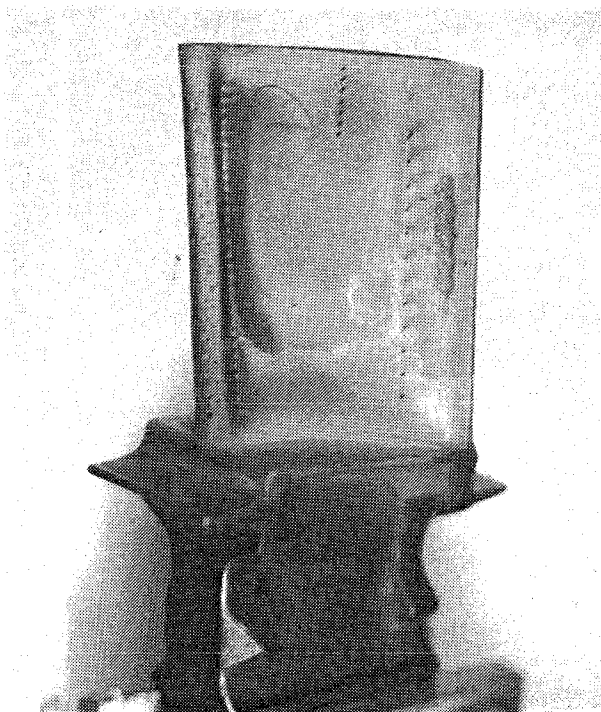
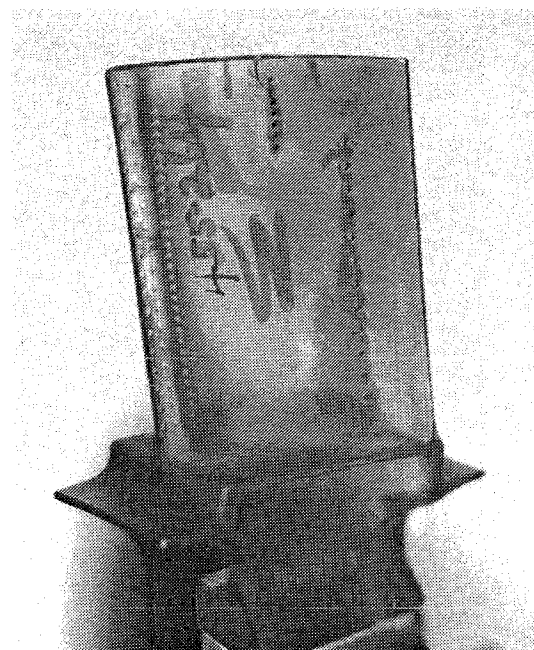
Figure 1b. Stage 1 High Pressure Turbine Blades from CF6-50 Engine.

Southern Africa: A300B  
1830 hours, 1471 Cycles

Western Europe: DC10-30  
2625 hours, 610 Cycles

This was the least distressed of the four CF6-50 turbine blades. There was faint visual evidence for Type 1 sulfidation within the coating (which was not breached) in the 10% section, at the leading edge and at 60-80% chord, maximum penetration about 45  $\mu\text{m}$  (0.0018 inch). EDAX analysis of the scale showed strong Al and lesser amounts of Ti and Cr. Sulfur was, however, not confirmed.

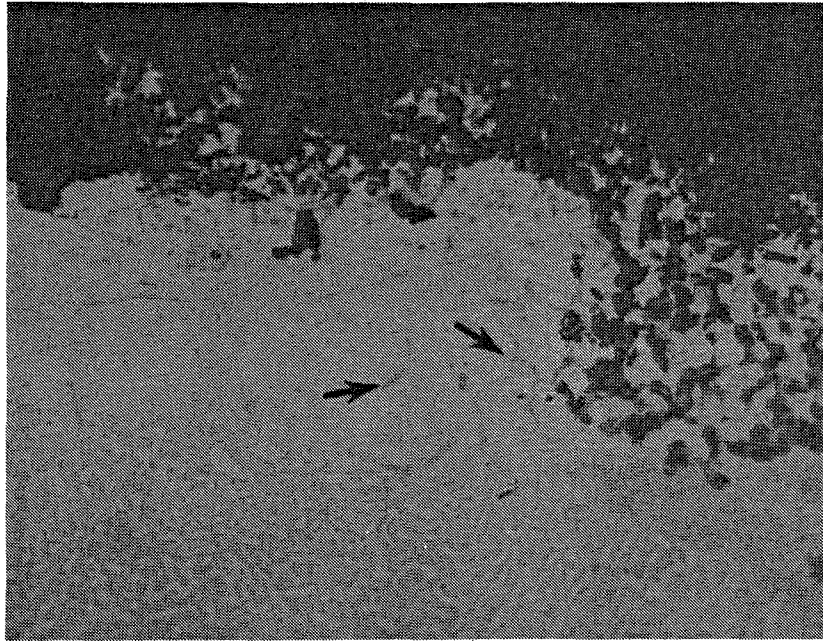
At the 40%/70-90% location, the coating was breached and some attack of the substrate was evident. Maximum distress was about 100  $\mu\text{m}$  (0.004 inch). Type 1 subsurface sulfides were clearly visible, as shown in Figure 2, within remaining coating at the edge of the distressed region. Confirmation that these particles were sulfides was obtained by EMP as shown in Figure 3.

Figure 2. Photomicrograph at the 40%/80% Location on the Concave Airfoil of a Stage 1 High Pressure Turbine Blade from a Southern Asia CF6-50 Engine. Type 1 Sulfides are Present (Arrows).

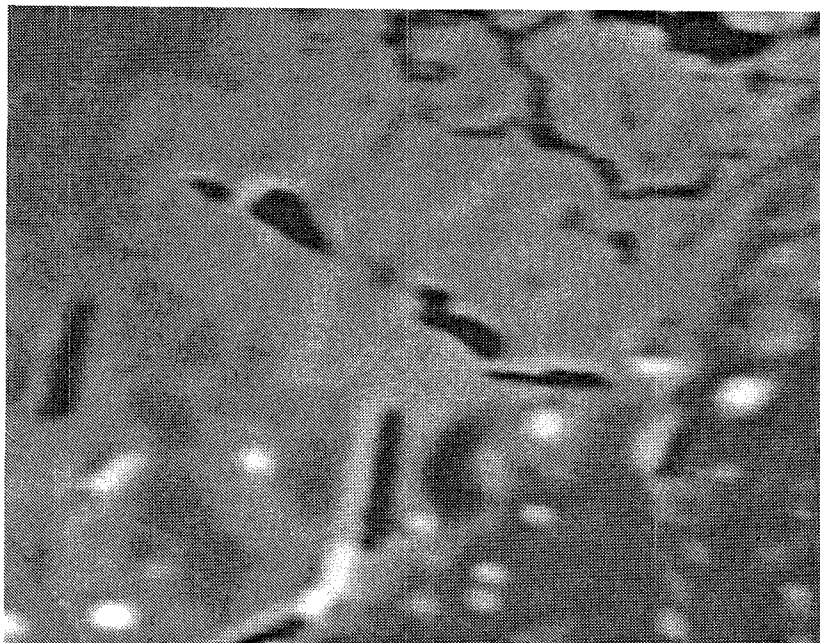
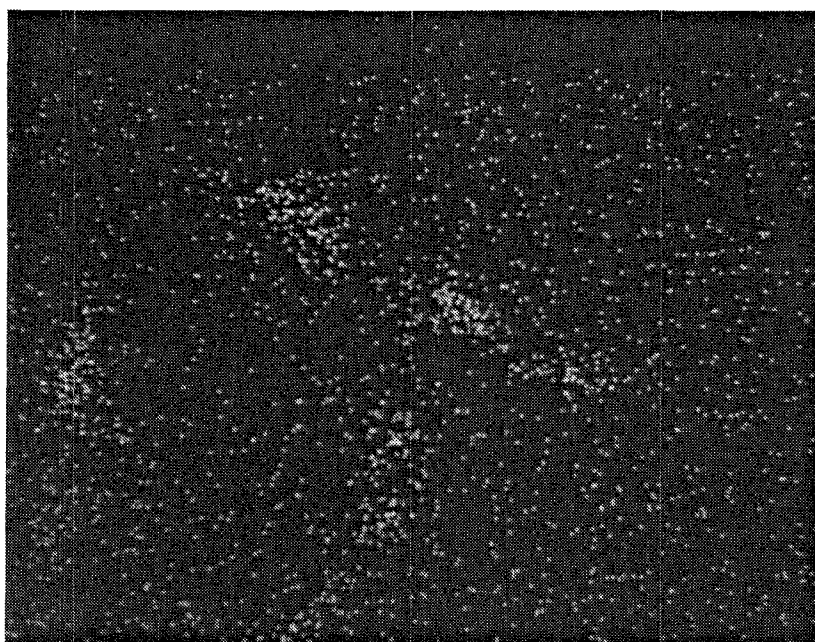
Figure 3. EMP Configuration of Sulfides in the Gray Subsurface Particles Shown in Figure 2. Stage 1 High Pressure Turbine Blade from a Southern Asia CF6-50 Engine (5000X).

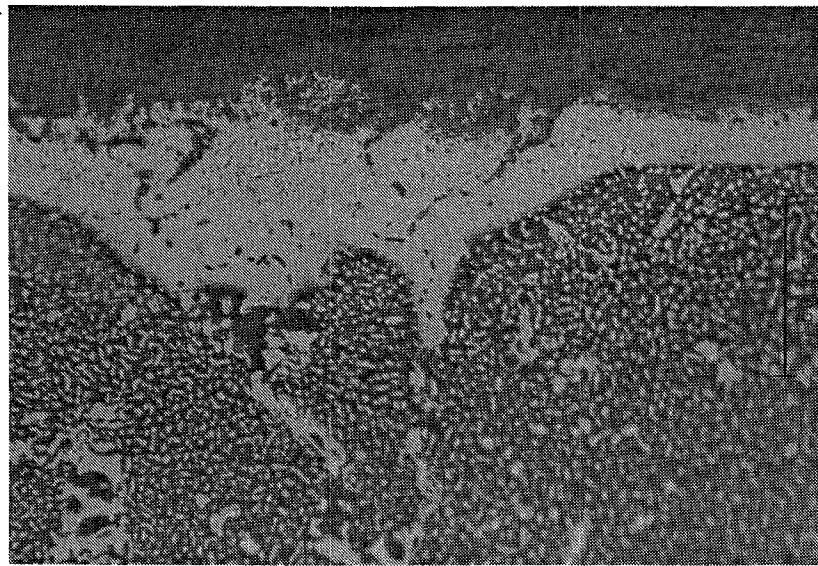
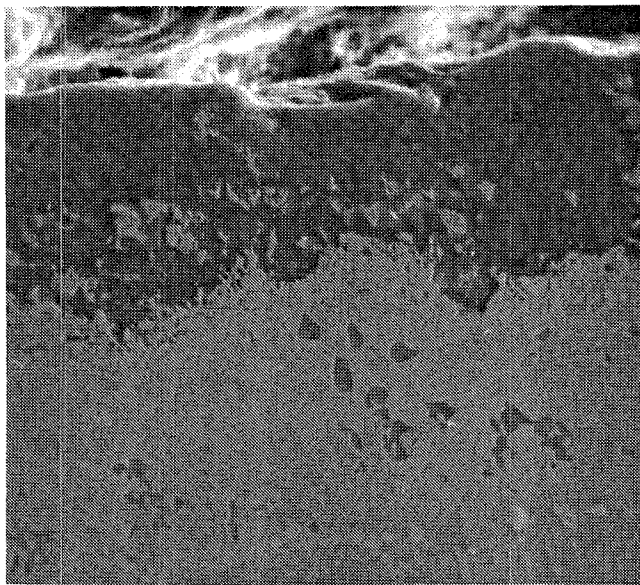
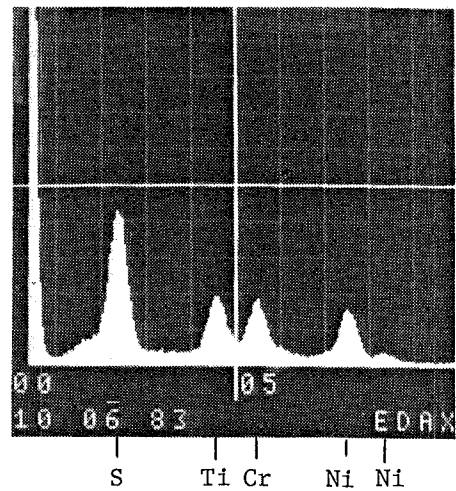
At the 50%/60-90% location, the coating was breached and considerable loss of the substrate alloy had occurred to a total depth of about 230  $\mu\text{m}$  (0.009 inch) including a depletion layer. Type 1 subsurface sulfides were clearly visible as shown in Figure 4, together with strong EDAX confirmation of sulfur, combined with Ti, Cr, and Ni. The scale was Cr and Al rich with some Ti. Although Ca was not observed by EDAX,  $\text{CaSO}_4$  was identified by X-ray diffraction from a scale specimen adjacent to the cut region. The depletion zone in the substrate showed lower levels of Cr, Al, and Ti than in the unaffected René 80. At the 80%/50-80% location, similar structures were observed, again to a maximum depth of about 230  $\mu\text{m}$  (0.009 inch).

Figure 4. Photomicrographs at the 50%/60-90% Location on the Concave Airfoil of a Stage 1 High Pressure Turbine Blade from a Northern Africa CF6-50 Engine. The Gray Subsurface Particles in (b) were Identified by EDAX as Sulfides Containing Ni, Cr, and Ti.

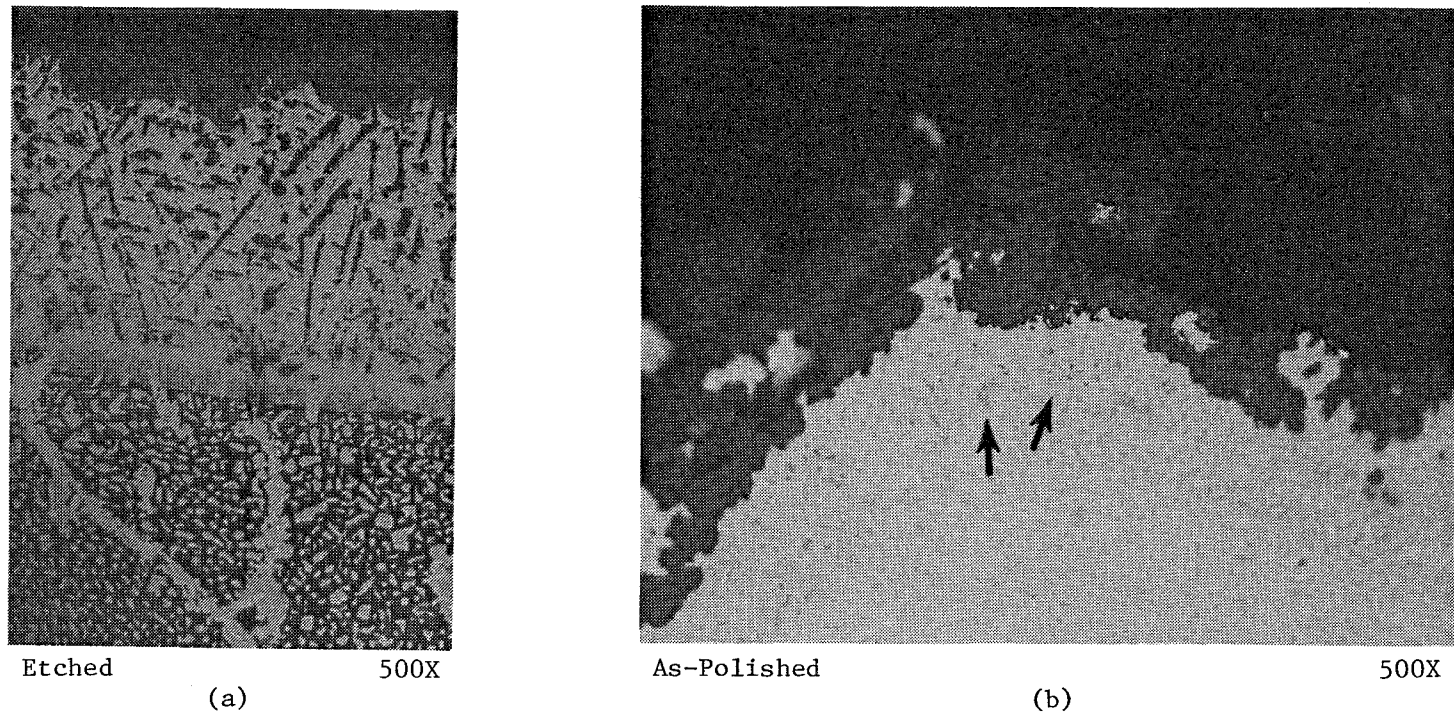
For this blade, the maximum distress of about 180  $\mu\text{m}$  (0.007 inch) was observed at the 60%/90% location and showed the structural features of oxidation only (Figure 5a). No sulfides were found by EDAX examination. The scale contained substantial amounts of Ca and some Fe (from the environment) as well as Al.

Figure 5. Photomicrographs at the (a) 60%/90% Location on the Concave Airfoil and (b) 10%/LE Location of a Stage 1 High Pressure Turbine Blade from a Southern Africa CF6-50 Engine.

- (a) Conventional Oxidation with No Evidence of Sulfides
- (b) Considerable Subsurface Sulfides Within Residual Coating (Arrows)

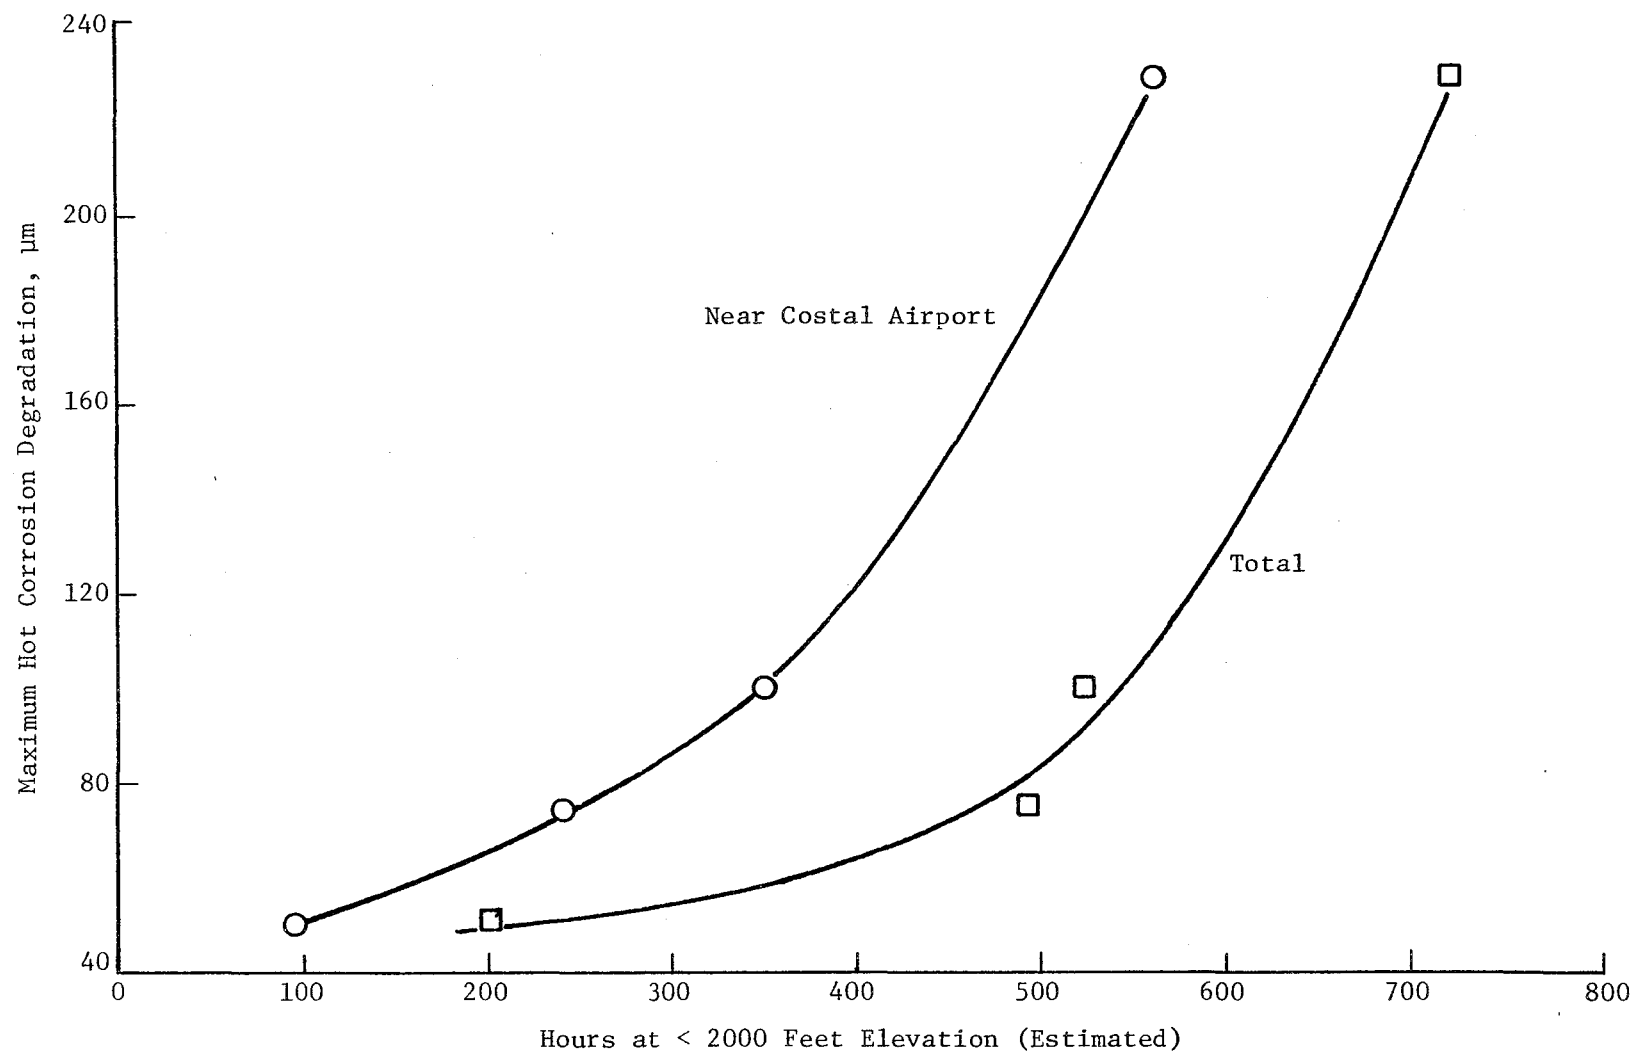
Alternatively, the trends shown in Figure 7 may reflect total times at takeoff/thrust reverse (higher) temperatures, a parameter which is clearly related to total hours at low altitudes. This is shown in rate units (Figure

Figure 7. Hot Corrosion Degradation for CF6-50 Stage 1 High Pressure Turbine Blades as Function of Time at Less Than 2000 Feet Elevation.

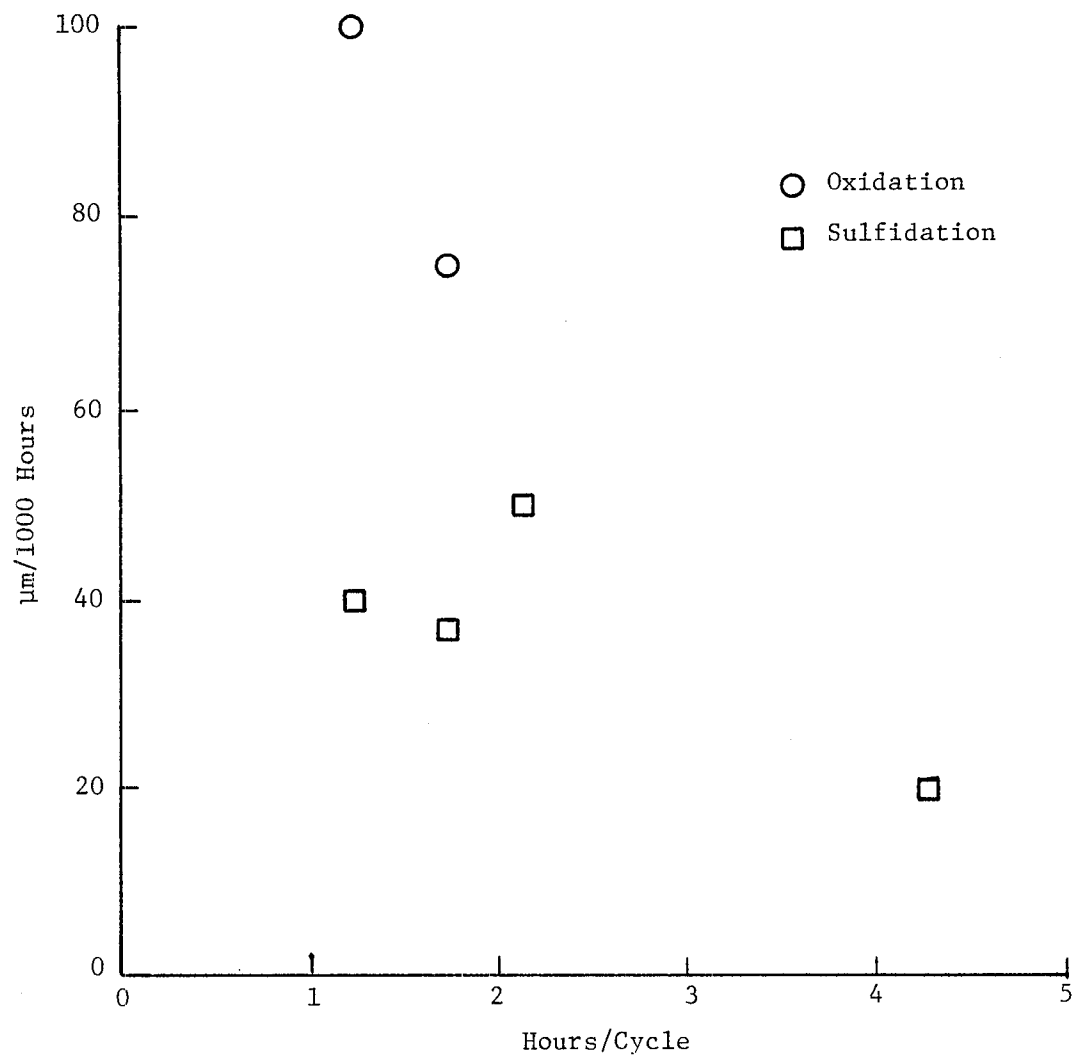
Figure 8. Maximum Degradation Rates for CF6-50 Stage 1 High Pressure Turbine Blades as Function of Average Mission Duration.

8). The highest rates correspond to the shortest lengths of mission for which the percentage of time at higher temperatures (or lower altitude) is greater.

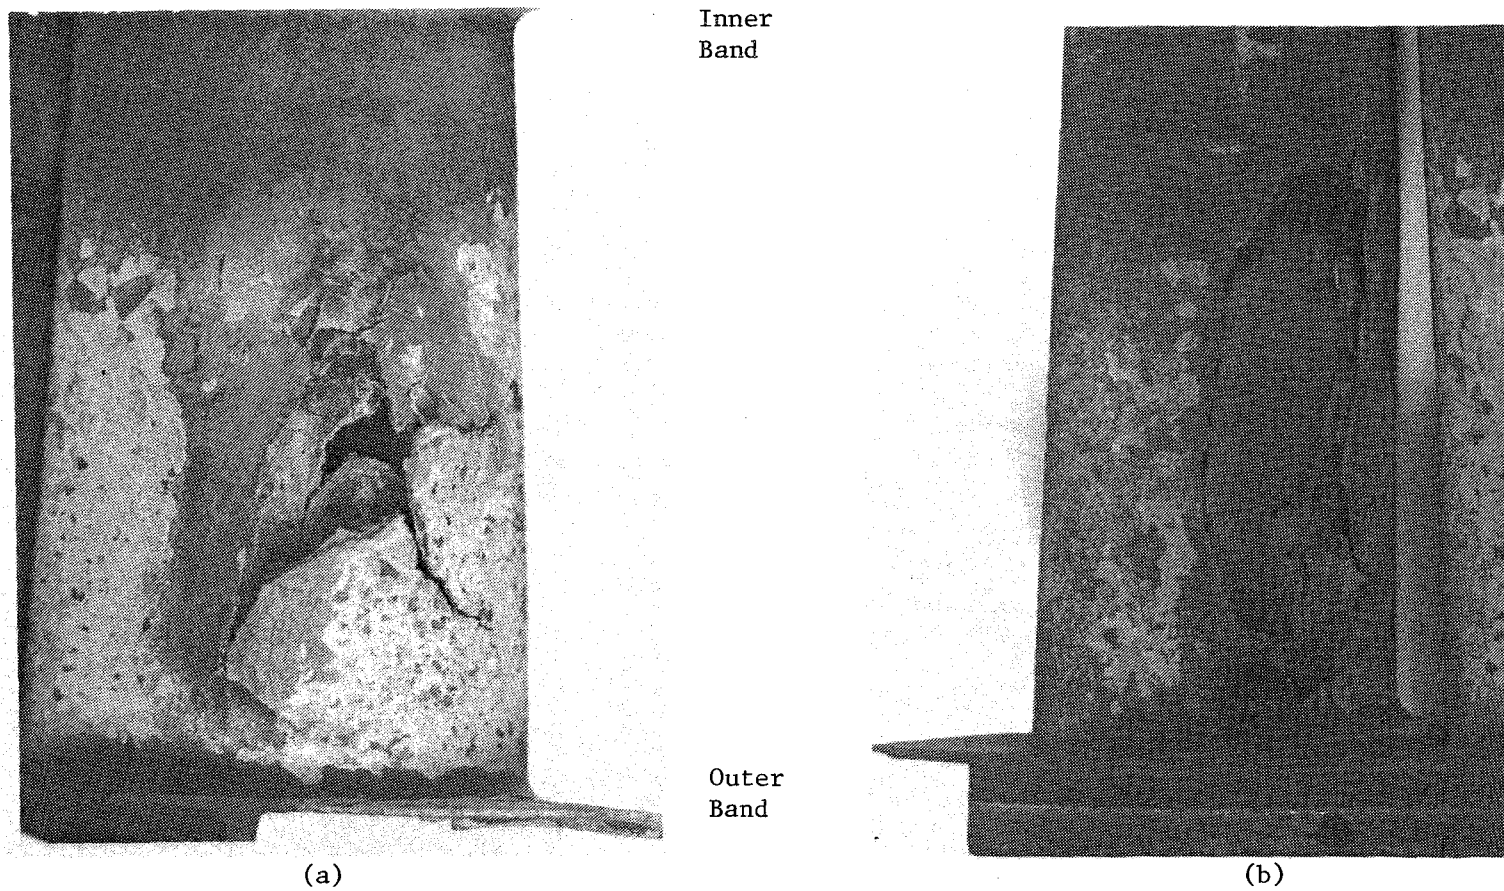
may not evaporate during high altitude operation in subsequent missions. This is particularly true of the relatively stagnant internal cavities. In the present example, inside-out corrosion from such deposits was so severe as to penetrate through the airfoil in some locations. The present evaluation, however, is confined to external surfaces which can be unambiguously related to operating parameters and to degradation of other components elsewhere in the engine. Photographs of two adjacent vanes are shown in Figure 9.

Figure 9. Stage 1 Low Pressure Turbine Vanes from a South America CF6-50 Engine, 15,155 hours of Service.

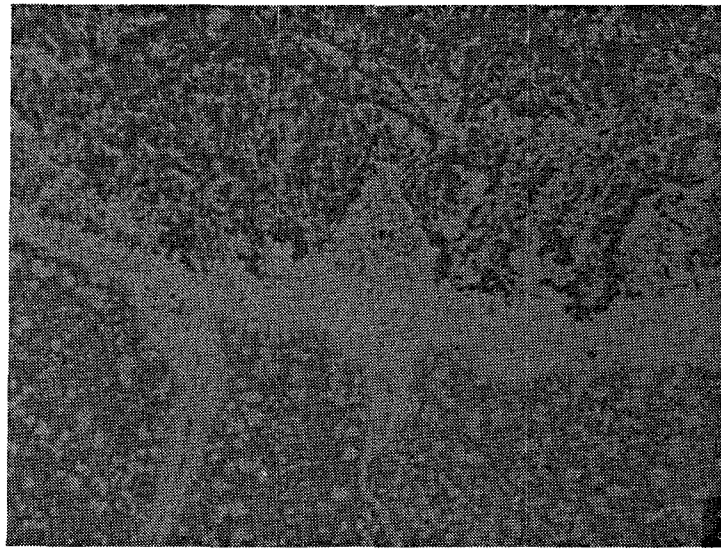
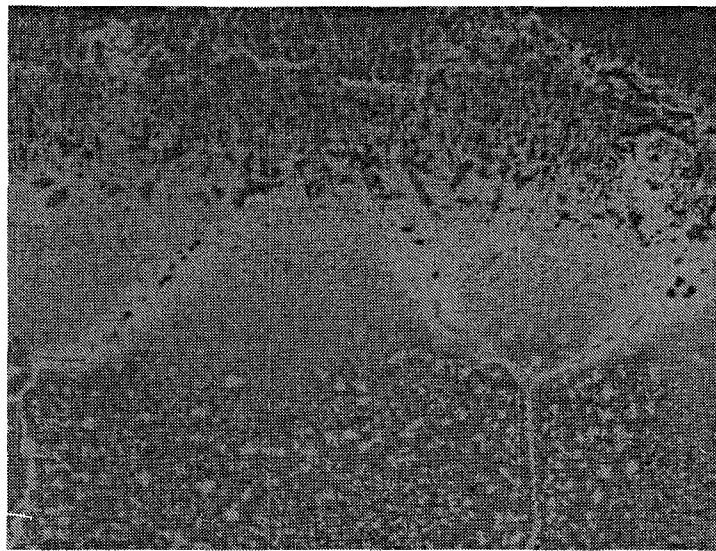
Metallographic sections were prepared for the 80% span of both of these vanes (measured outwards from the inner flange). Type 1 sulfidation was prevalent and extensive at many locations on both concave and convex surfaces - unlike high pressure turbine blades where very little degradation occurs on the convex surface. Maximum attack was about 400  $\mu\text{m}$  (0.016 inch), including depletion zone, at several locations on both sections examined. There was no evidence of Type 2 corrosion. Typical microstructures are shown in Figure 10, and EMP evidence for subsurface sulfides in Figure 11. The scale is rich in Ni and Cr, low in Al, and the  $\gamma'$ -free region of the René 77 is typically depressed in Cr, Al, and Ti.

Figure 10. Photomicrographs Showing Type/Sulfidation on a Stage 1 Low Pressure Turbine Vane from a South American CF6-50 Engine.

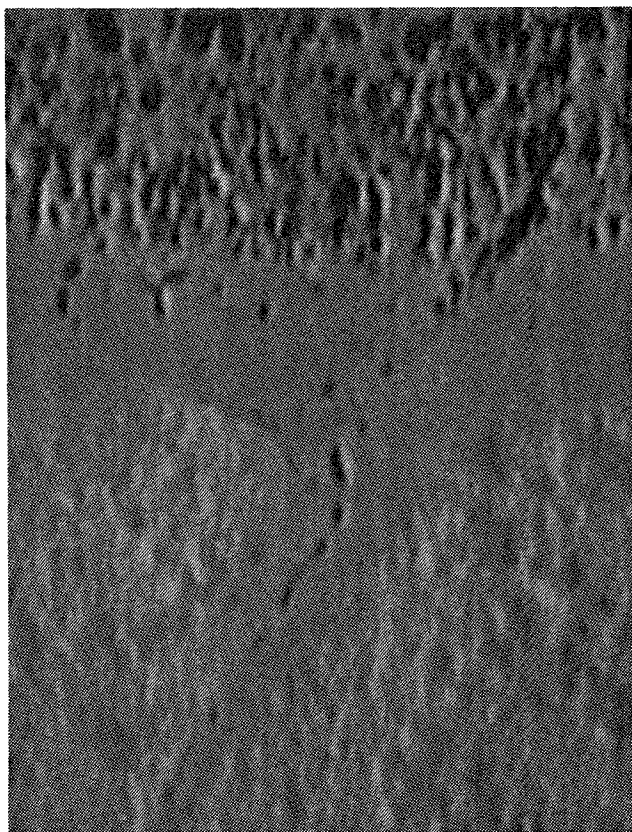
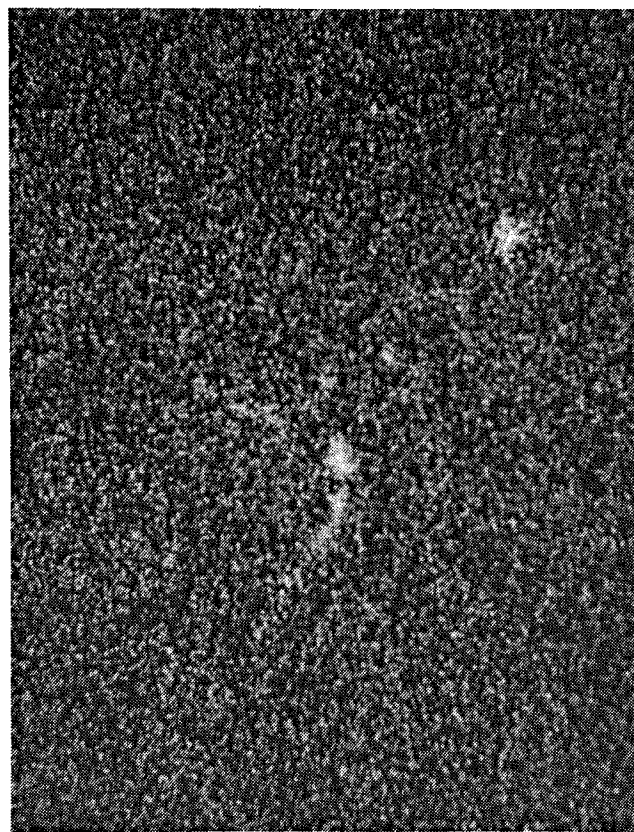
Figure 11. EMP Confirmation of Sulfides in the Gray Subsurface Particles Shown in Figure 10. Stage 1 Low Pressure Turbine Vane from a South America CF6-50 Engine (2000X).

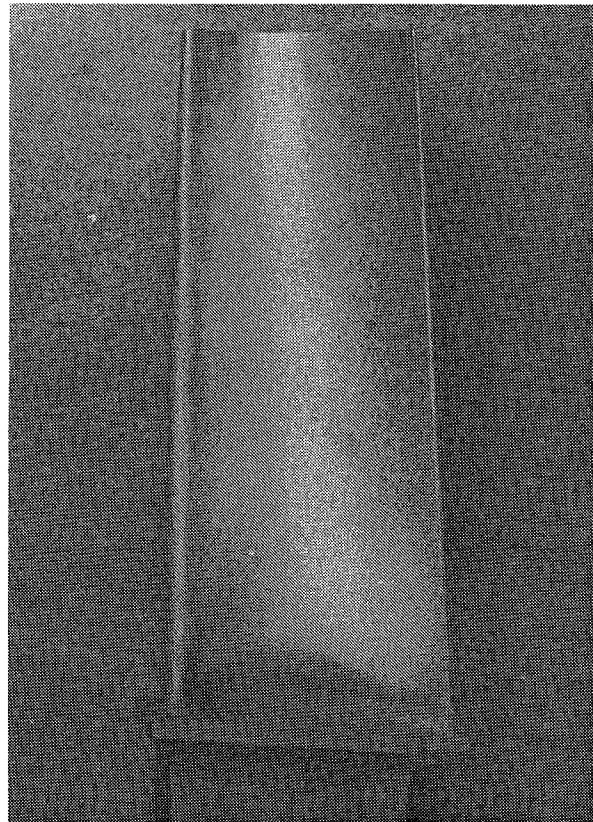
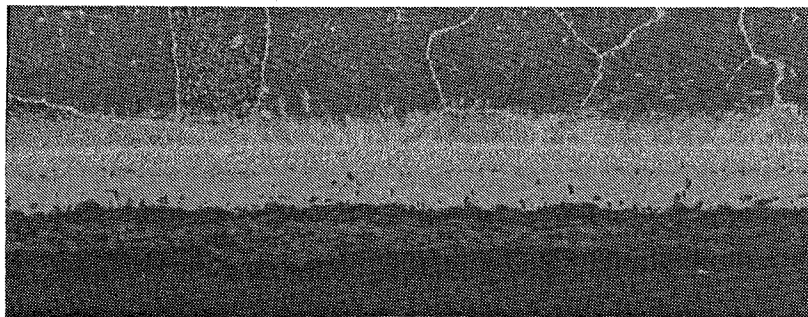
This Stage 1 high pressure turbine blade is the least distressed in the present study. Detailed examination of 60% and 80% sections failed to reveal sulfides. The maximum distress was observed to be about 25  $\mu\text{m}$  (0.001 inch) at the 80%/80% location for which the maximum operating temperature is estimated

as about 870° C. At this location, where the coating is less than half consumed, the scale is predominantly aluminum oxide, and contains small amounts of Ca and Fe derived from the environment. A photograph of this blade and a typical microstructure are shown in Figure 12. (Sulfidation has occasionally been identified on other J79 HPT blades. Thus the one depicted in Figure 12 is not an extreme example as is the case for the other five components in this survey.)

Figure 12. Stage 1 High Pressure Turbine Blade from a U.S. Military J79 Showing Degradation of the Codep Coating at the 80% Location on the Concave Airfoil.

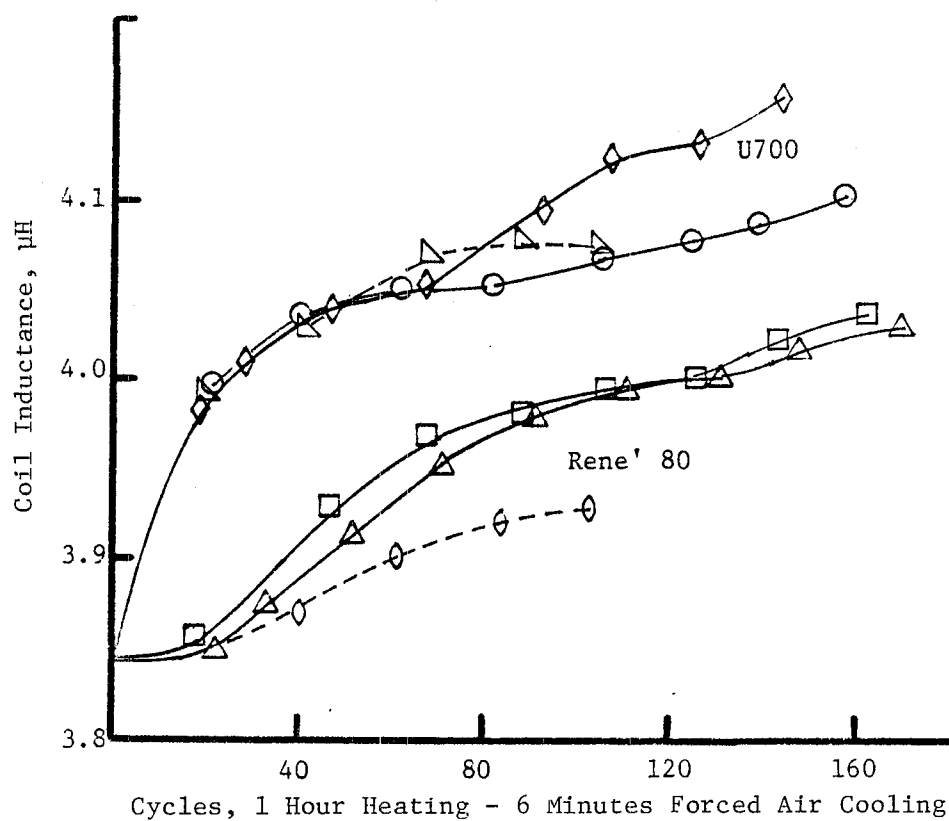
Other specimens removed from test thus far are listed in Table VI, together with total exposure times and the numbers of thermal cycles which did not receive forced air cooling. Graphs of coil inductance measurements for the six uncoated specimens are shown in Figure 21. Curves for the U700 specimens, although not identical with that reported by Deadmore under comparable test conditions (Reference 3), show strong similarities in both shape and the magnitude of changes. Curves for the René 80 specimens show smaller changes, as expected for this more corrosion resistant alloy. Typical specimen macrophotographs are shown in Figures 22 and 23.

Figure 21. Uncoated Alloy Coil Inductance Changes with Hot Corrosion at 900° C, Cyclic Exposure.

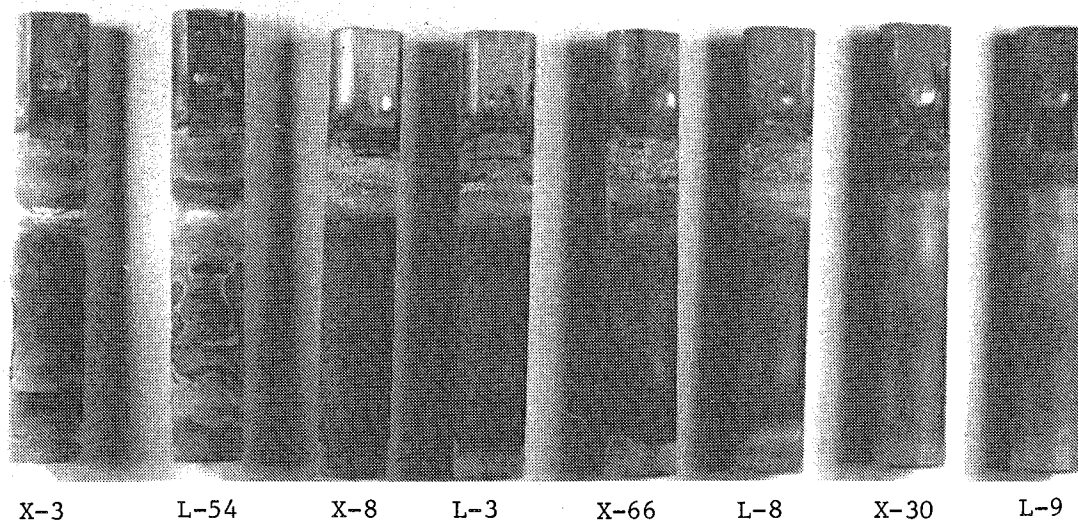
Figure 22. Uncoated U700 (X-3) Removed from Test After 142.65 hours, Rig 1.

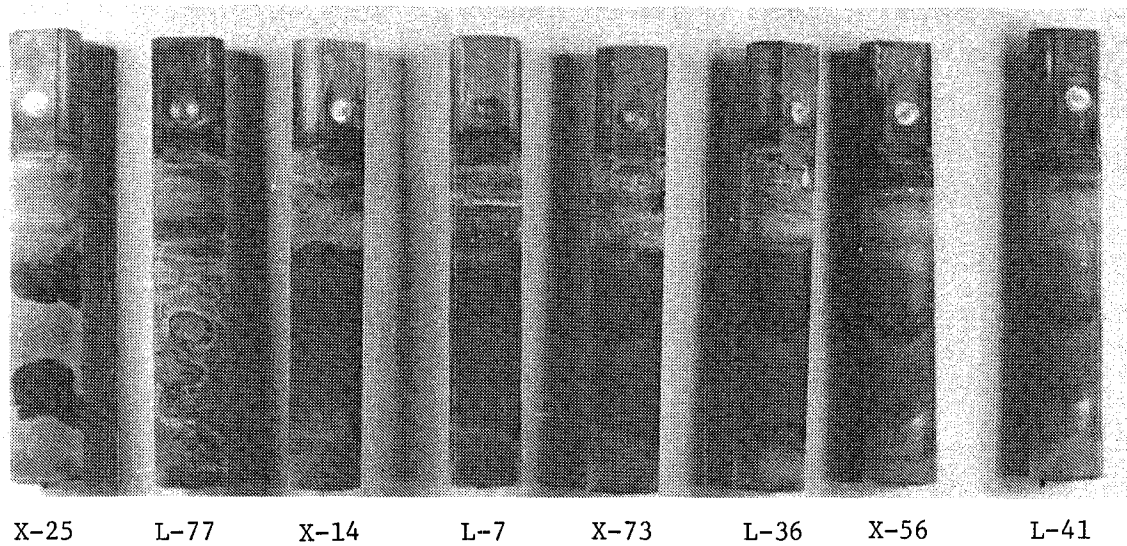
Figure 23. Uncoated René 80 (L-77) Removed from Test after 167.7 hours, Rig 2.

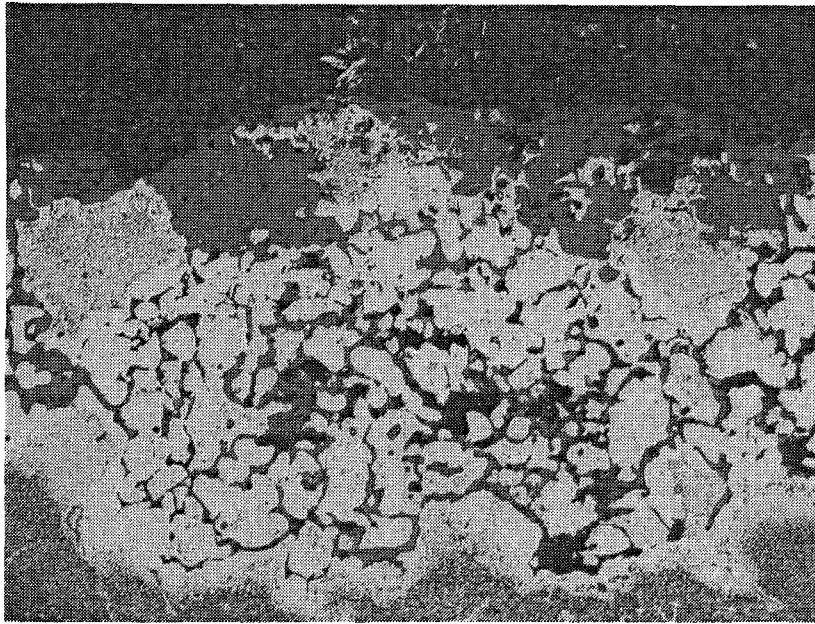
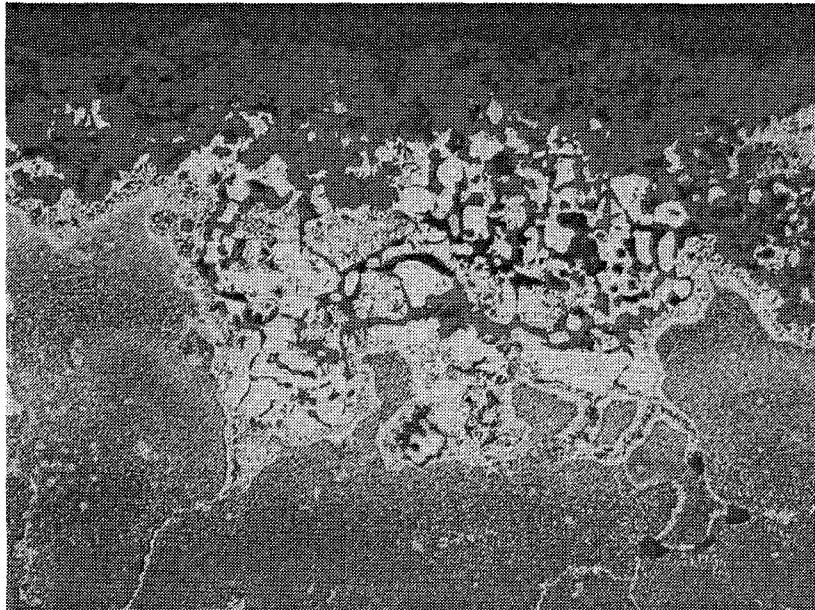
Metallographic sections of the uncoated specimens listed in Table VI have been prepared. Although the extent of attack was not uniform around the circumference of these specimens, Type I sulfidation was apparent at essentially all locations. Typical microstructures for U700 and René 80 showing a depletion zone in the alloy, containing subsurface sulfides, are shown in Figure 24. That the nature of this degradation is similar to that observed in field experience is apparent by comparison with Figures 4 and 10.

Figure 24. Photomicrographs of Specimens from Burner Rig Tests. Type 1 Sulfides are Present (Etched, 200X).
